Ref: EP-SL-002	ID: 0840
	V20-Replacement of M4 screws	Revision: 2.00
		Date: 27-Mar-2023
Page 1 of 1	SERVICE LETTER	Visa: SD

Affected Propellers: "Durandal V20" series produced before 2022.

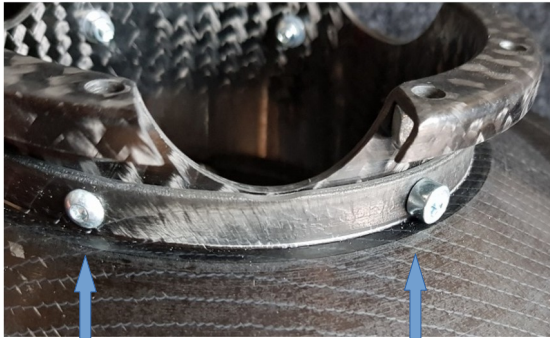
Reason: Corrosion on M4 screws for the fixation of the spinner back plate on the spacer.

Action: Replace the M4 screws by M5 screws without washers.

- Check the alignment of the back plate on the spacer.
- Tighten the M4 screws
- Remove one M4 screw, drill the hole to 5.00 mm, tighten the M5 screw to 5 N.m
- Repeat this operation for the other holes, in "star" order,

for example on a 3 blades Durandal :

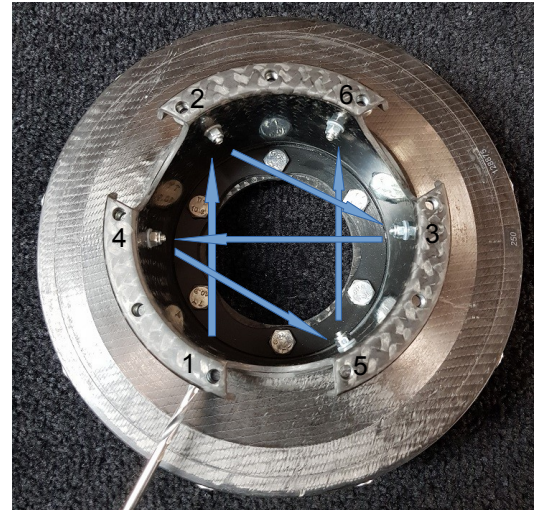
M4 screw

M5 screw
