Light Aircraft Association MANDATORY TECHNICAL DIRECTIVE

MTD-02-2026

E-Props Propellers

Cracking in E-Props Carbon Propeller Hubs

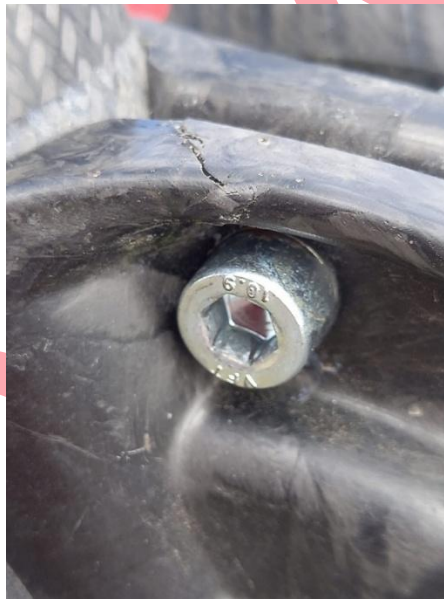
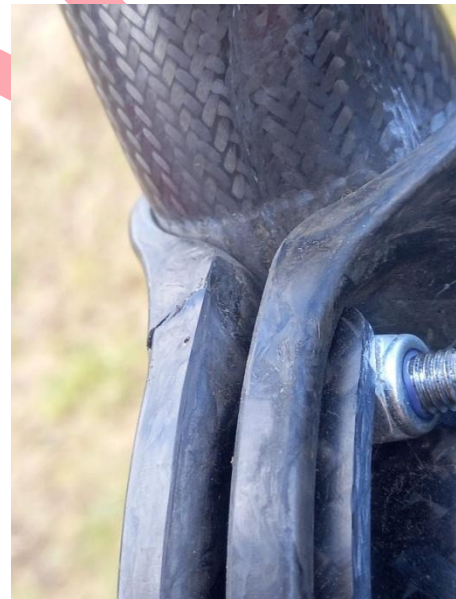
A 2025 report of a crack appearing on an E-Props carbon composite propeller hub was received by the British Microlight Aircraft Association (BMAA), as shown in the photos below. The crack was in the flange forming the periphery of the circular hub, in the close vicinity of one of the bolts in the outer ring of blade clamping bolts.

These cracks were the subject of LAA Alert A-10-2025, which requested that any evidence of cracks be reported to LAA Engineering before further flight. Since publication of this Alert, Engineering has taken advice on the subject, concluding that these cracks are most likely caused by over-tightening of the bolts as suggested by E-Props.

Given the implications of reduced clamping force and blade security for flight, this MTD is raised to mandate the removal of cracked E-Props carbon (CFRP) hubs from service.

Required Action(s)	<p>Operators of aircraft fitted with E-Props carbon (CFRP) hubs must:</p> <ol style="list-style-type: none"> 1. Inspect the propeller hub, removing the spinner as necessary, to check for any signs of cracking, paying special attention to the flange forming the periphery of the circular hub and the vicinity of any bolts. 2. If any cracks are detected, before further flight, the hub must be replaced with a serviceable, uncracked hub or the propeller replaced with an alternative propeller approved for that aircraft. <p>Repeat action:</p> <ol style="list-style-type: none"> 3. The inspection in Step 1 must be repeated at intervals not exceeding one calendar year. 		
Compliance Time(s)	<p>Initial Compliance Initial inspection of the hub to be carried out within the next 5 flying hours from the effective date of this MTD.</p> <p>Repeated Compliance The inspection in Step 1 must be repeated at intervals not exceeding one calendar year.</p>

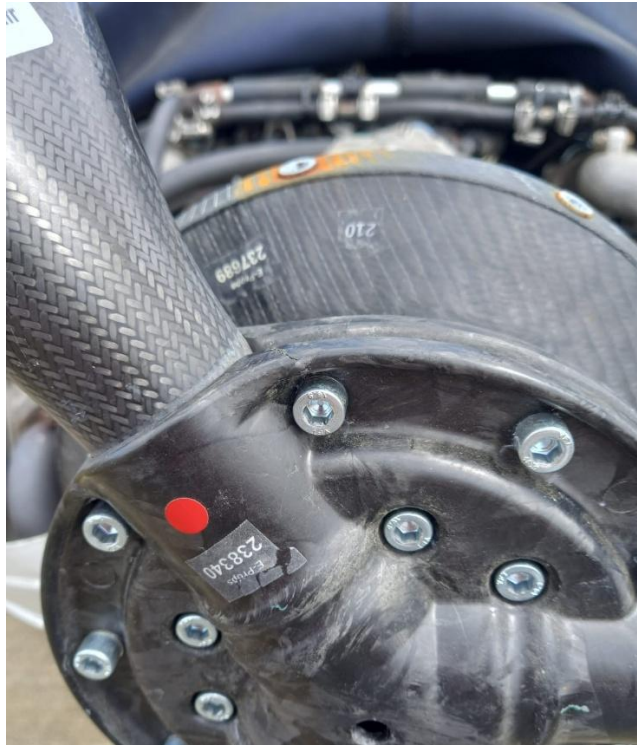
Although rapid propagation of a crack is unlikely due to the material properties of carbon (CFRP) hubs, in which the millions of fibres act as crack stoppers, the presence of these cracks may result in:

- a. Reduced clamping force, possibly allowing changes in blade pitch.
- b. Compromised blade root security in bending, possibly allowing the blade root to fret in the hub.
