SERVICE BULLETIN

N° EP-SB-2026-001

May 24, 2026

Affected propellers:	27 propellers: 3-blade models for tractor ultralights equipped with Rotax 912 & 912S engines (DURANDAL), manufactured in late 2019 . Models: DU 80 MT 160, DU 80 MT 170, DU 100 MT 165, DU 100 MT 170, DU 100 MT 175. See Section 3 for the complete list of affected blade serial numbers.
Reason:	Potential progressive debonding of the blade leading-edge protections, caused by an initial adhesive bonding process used exclusively on the first 27 propellers produced.
Description:	One case of protection detachment has been reported, with no safety consequence. Since January 2020, an improved bonding process has been in use with no issues on several thousand propellers delivered worldwide.
Action:	Return the blades to E-Props within 30 days for re-bonding of the leading-edge protections at no charge. Sending the complete propeller assembly (blades, hub, spacer and spinner) is strongly recommended.

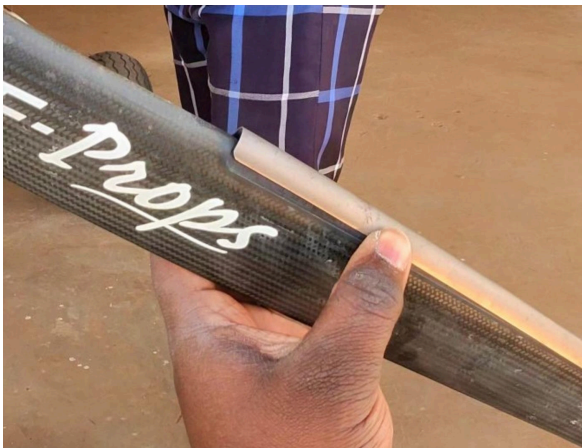
It has since been found that this initial bonding process may be less durable than expected over time. No issue was reported for several years; however, a case of protection detachment has been reported on one propeller from this batch (Fig. 1 and Fig. 2): May 22, 2026 in Niger. Fortunately, no safety incident occurred as a result of this event.

Fig. 1 – Blade with leading-edge protection detachment

The root cause has been identified as a production error in the surface preparation of the titanium leading-edge protection prior to bonding. An inadequate surface preparation resulted in insufficient adhesion between the titanium part and the blade.

E-Props offers to replace the blade leading-edge protections on all affected propellers.

Item	Details
Impacted parts	Leading-edge protections on the 3 blades of the affected propeller.
Modification	Removal of the existing protections and re-bonding new Titanium parts using the improved adhesive process that has been in use since January 2020.
Urgency	No immediate grounding required. The corrective action must be completed within 30 days of receipt of this Service Bulletin.
Procedure	Send the blades — or preferably the complete propeller assembly (blades + hub + spacer + spinner) — to E-Props at the address below. When the complete assembly is received, E-Props will also perform a full inspection and a rebalancing to ensure optimal performance.
Shipping address	HELICES E-PROPS 195, Route de l'Aviation – ZI Aérodrome de Sisteron 04200 VAUMEILH – France Return reference : SB-T Contact : Antoine Phone : +33 (0)4 92 34 00 00 Email : as@e-props.fr – helices@e-props.fr
Cost	Free of charge. The re-bonding, full inspection and rebalancing are entirely covered by E-Props.

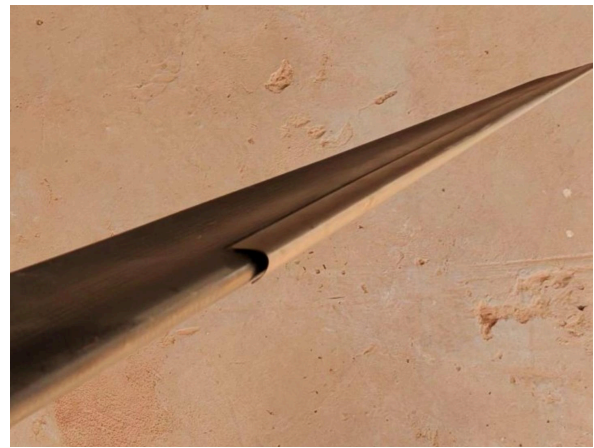
Fig. 2 – Detail of the debonded leading-edge protection
